Standard Building Inspection For: Inspector Gadget

29 NW Havenshire Circle, Lawton, Ok

Date of Inspection: 7/7/2009

Standard Inspection REPORT

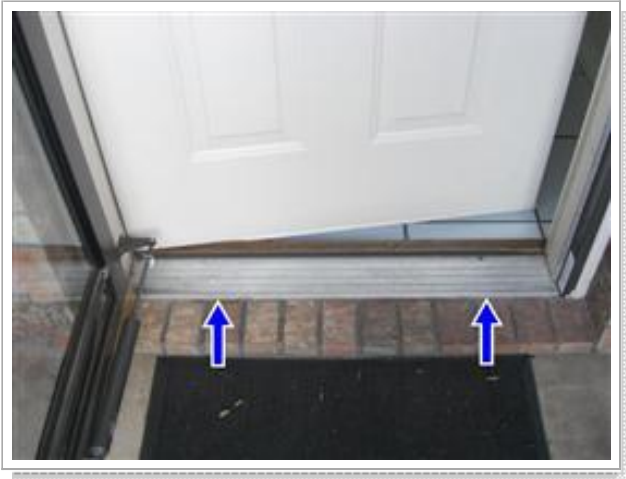
Figure Number 1

Threshold does not appear water tight at exterior door(s). Suggest securing with liquid nails and then caulking front edge of threshold. (See Figure #1)

- Threshold does not appear water tight at exterior door(s). Suggest securing with liquid nails and then caulking front edge of threshold. (See Figure #1)

Threshold does not appear water tight at exterior door(s). Suggest securing with liquid nails and then caulking front edge of threshold.

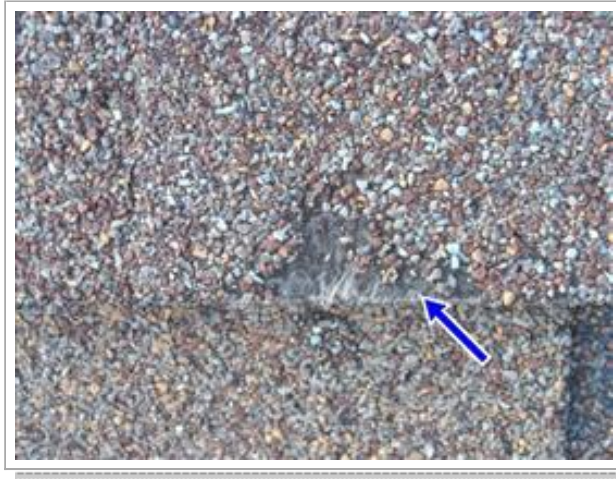
Figure Number 2

Slight hail damage to roofing materials on south side of structure; make sure roof is insurable. (See Figure #2) (See Figure #3) (See Figure #4)

Slight hail damage to roofing materials on south side of structure; make sure roof is insurable.

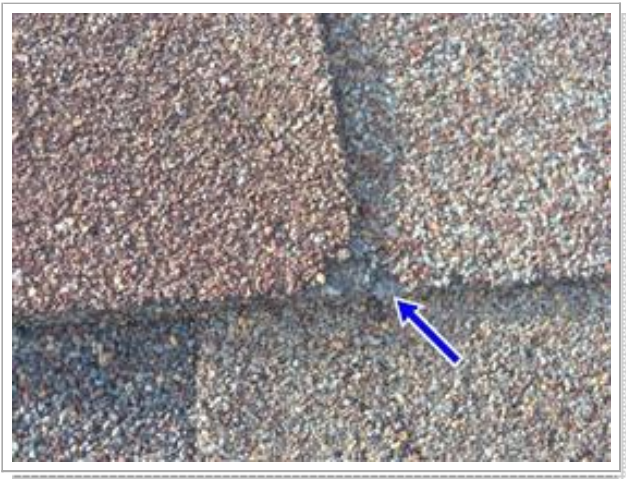
Figure Number 3

Slight hail damage to roofing materials on south side of structure; make sure roof is insurable.

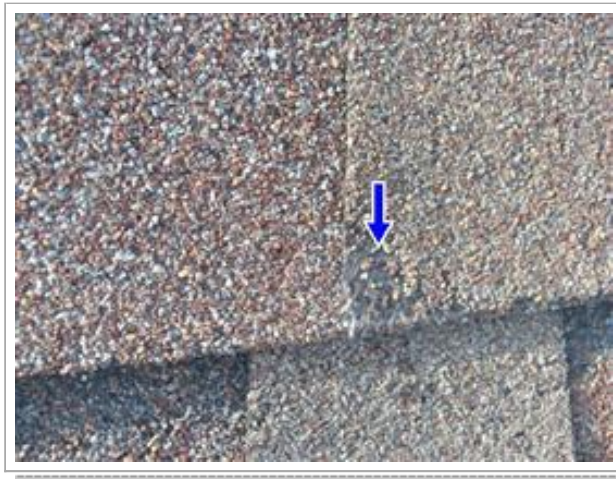
Figure Number 4

Slight hail damage to roofing materials on south side of structure; make sure roof is insurable.

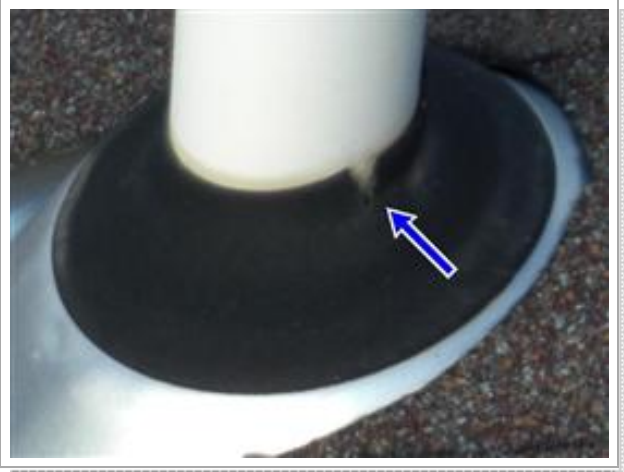
Figure Number 5

Neoprene vent collars appear aged & cracked allowing possible moisture intrusion at roof level. Replace where needed. (See Figure #5) (See Figure #6)

Neoprene vent collars appear aged & cracked allowing possible moisture intrusion at roof level. Replace where needed.

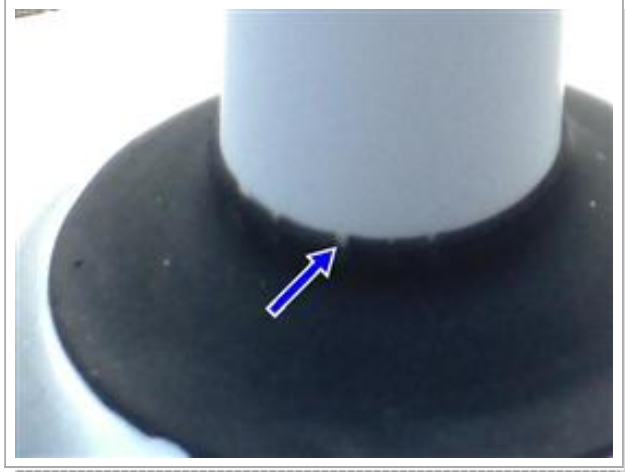
Figure Number 6

Neoprene vent collars appear aged & cracked allowing possible moisture intrusion at roof level. Replace where needed.

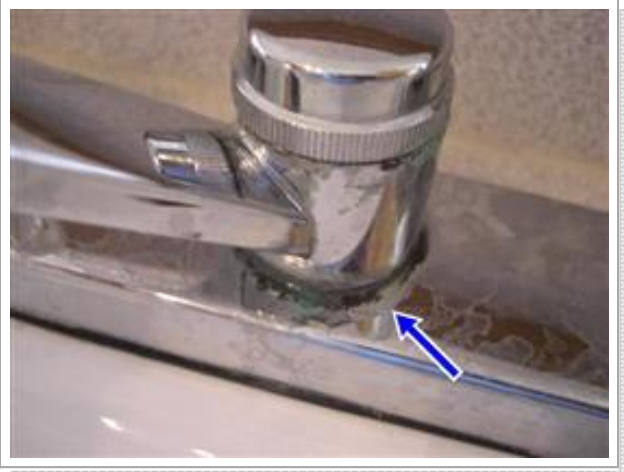
Figure Number 7

Leakage noted at base of kitchen faucet. (See Figure #7)

Leakage noted at base of kitchen faucet.

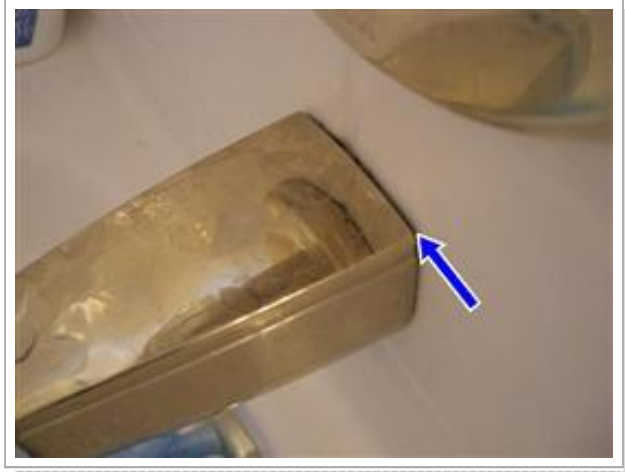
Figure Number 8

Suggest caulking around bathroom escutcheons at tub enclosures. (See Figure #8)

Suggest caulking around bathroom escutcheons at tub enclosures.

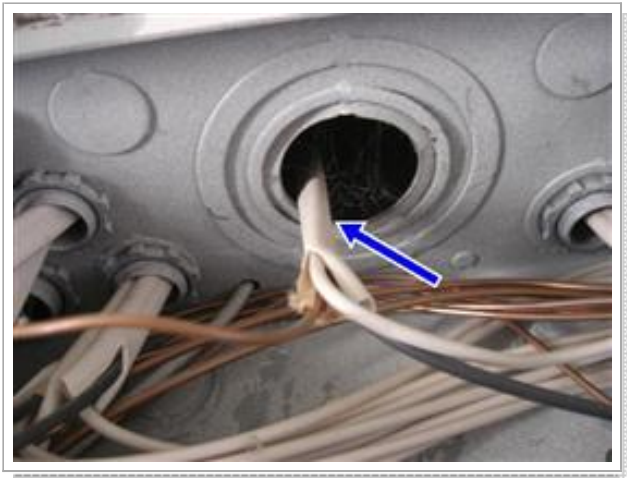
Figure Number 9

Missing panel bushings at added wiring in main panel. (See Figure #9) (See Figure #10)

Missing panel bushings at added wiring in main panel.

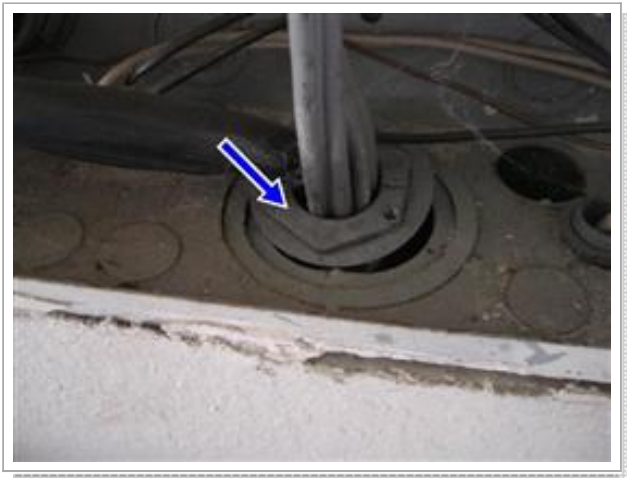
Figure Number 10

Missing panel bushings at added wiring in main panel.

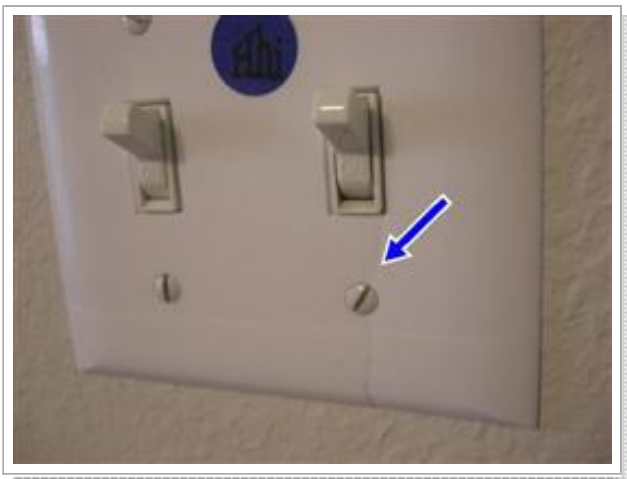
Figure Number 11

Damaged/ cracked receptacle cover noted in bedroom. Marked with blue dot. (See Figure #11)

Damaged/ cracked receptacle cover noted in bedroom. Marked with blue dot.

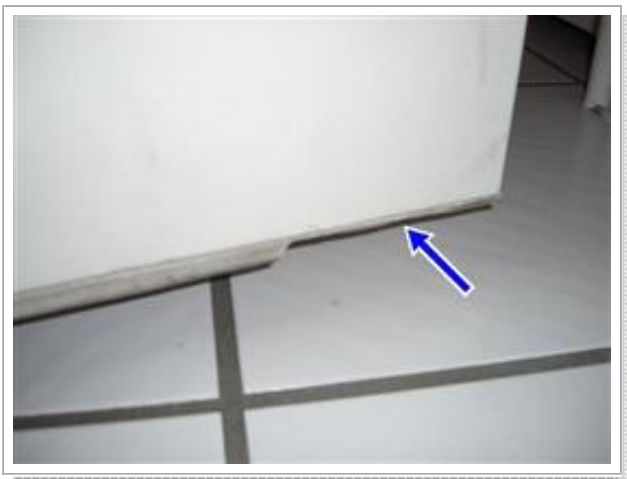
Figure Number 12

Damaged threshold seal noted at base of laundry room to garage door. (See Figure #12)

Damaged threshold seal noted at base of laundry room to garage door.
